**INSPECTION REPORT OF
CONSTRUCTION RELATED ACTIVITIES AT
ST. QUEUNTENS PLANTATION (38BU968),
WALLING GROVE, BEAUFORT COUNTY, S.C.**

**INSPECTION REPORT OF
CONSTRUCTION RELATED ACTIVITIES AT
ST. QUEUTENS PLANTATION (38BU968),
WALLING GROVE, BEAUFORT COUNTY, S.C.**

Prepared By:
Michael Trinkley, Ph.D.

January 17, 1997

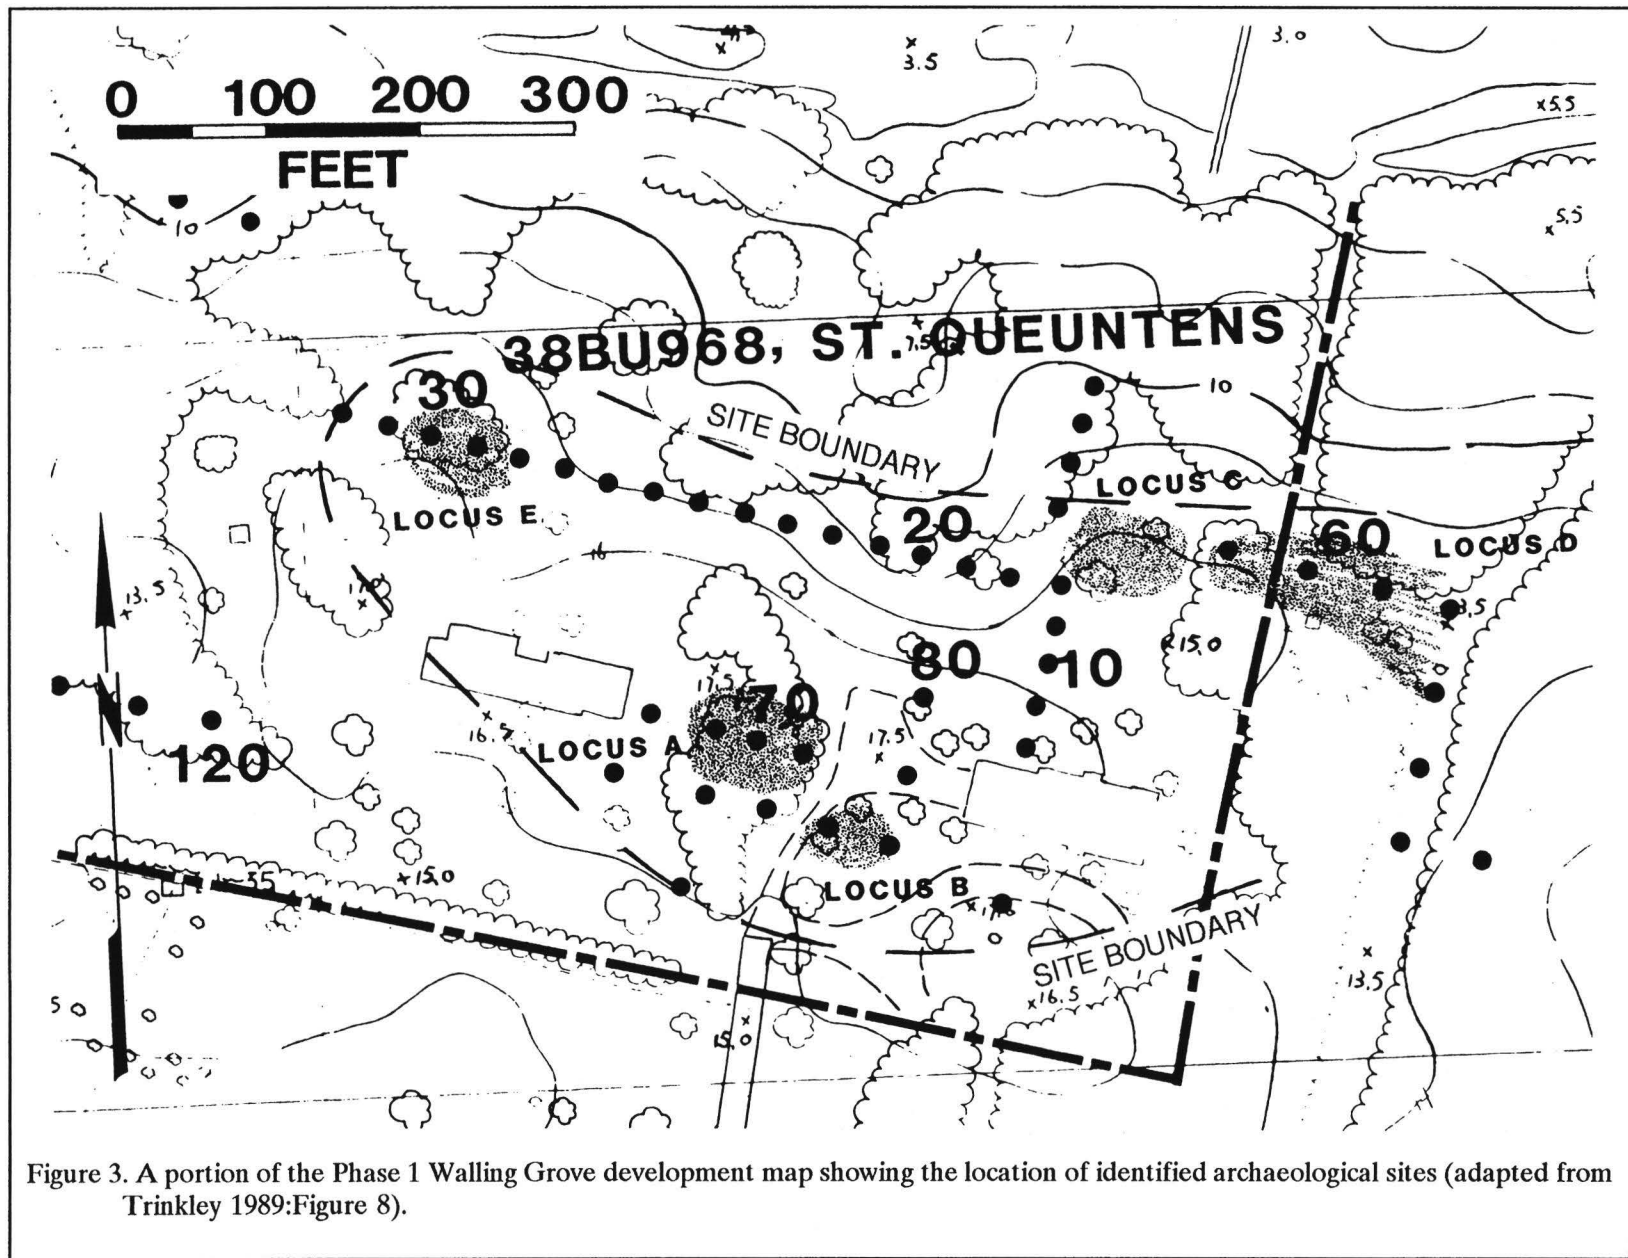
Figure 3. A portion of the Phase 1 Walling Grove development map showing the location of identified archaeological sites (adapted from Trinkley 1989:Figure 8).

The site as it was identified during the original survey is shown here as Figure 3. Note that the map reveals both the site boundary, identified by the dashed line, and the approximate area of the different loci.
